1. AGENCY USE ONLY (Leave blank)	2. REPORT DATE 1996	3. REPORT TYPE AND DATES COVERED Final Report		
4. TITLE AND SUBTITLE The Old Hospital Complex (5EP1778) Fort Carson, Colorado		5. FUNDING NUMBERS

13. ABSTRACT (Maximum 200 words) <p>The Old Hospital Complex (5EP1778) at Fort Carson, Colorado, consists of 59 buildings. The Complex was built during World War II and is significant due to its association with the history of the United States. The complex is semi-permanent construction, constructed from the Department of the Army's Series 800 plans. This report documents the complex in accordance with Section 1(g) of the Memorandum of Agreement enacted among the Department of the Army, Headquarters Fort Carson, the Colorado State Historic Preservation Office, and the Advisory Council on Historic Preservation.</p> <p style="text-align: center;">DTIC QUALITY INSPECTED 2</p>

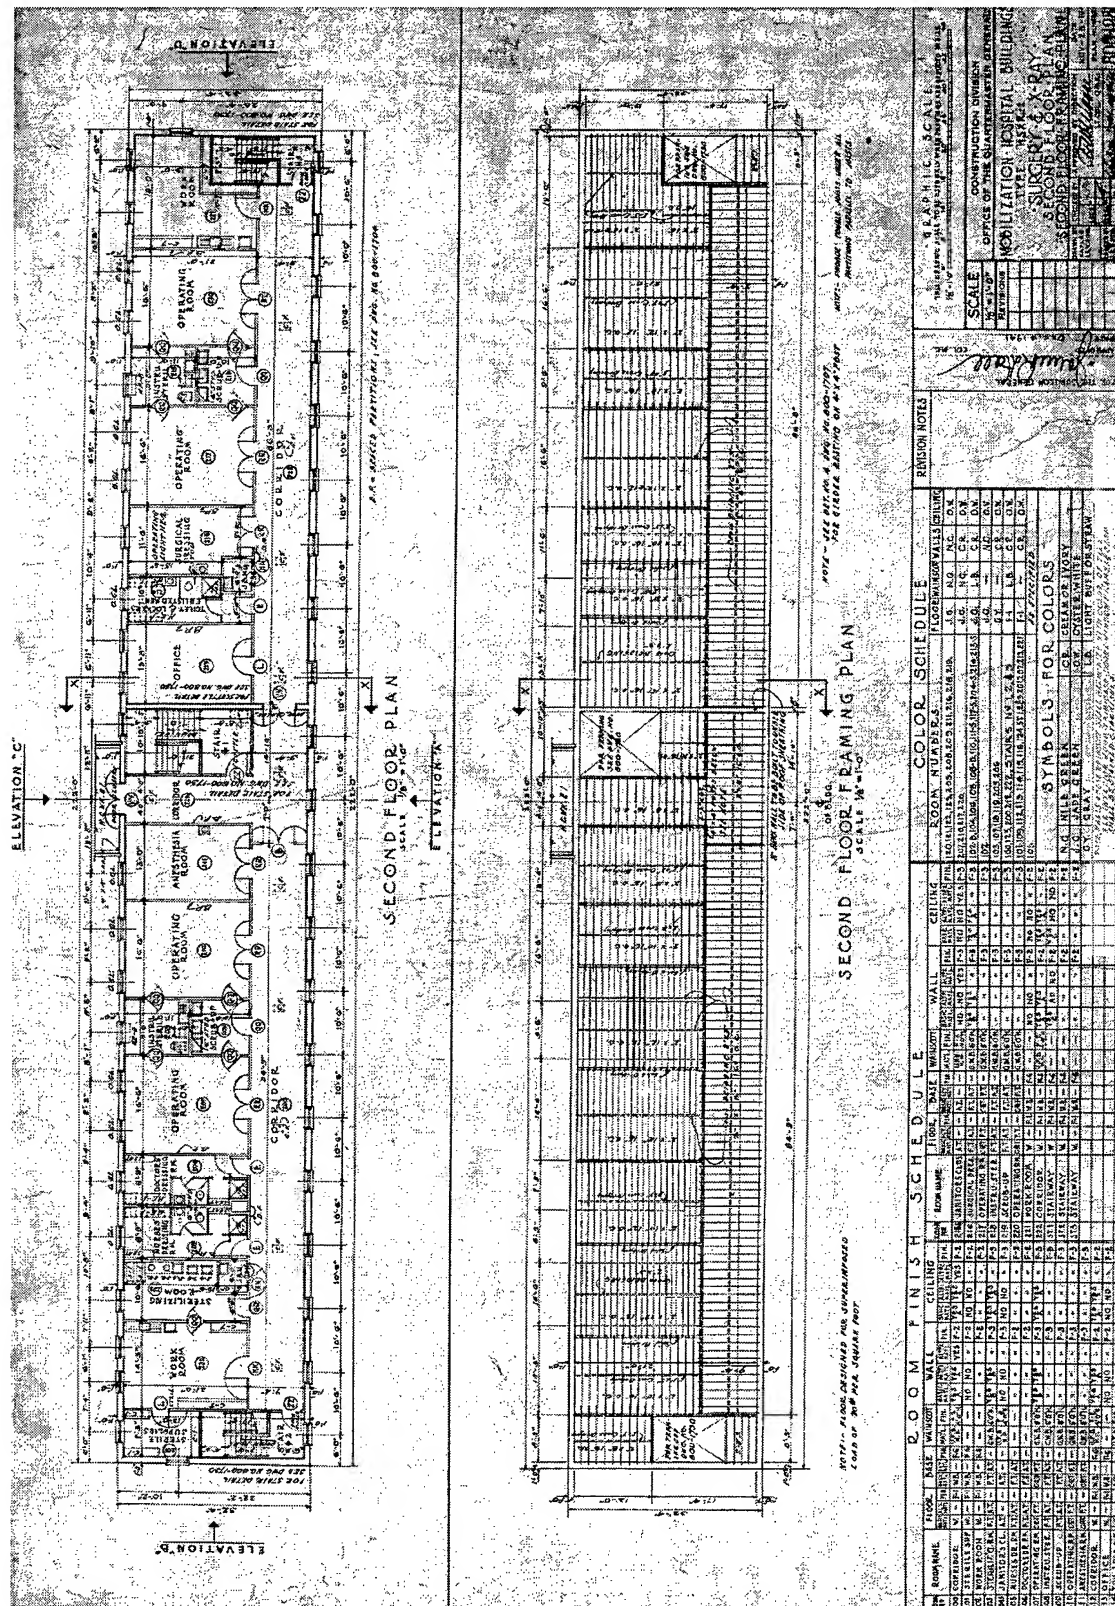
Figure V.55 5EPI778. Second-floor plan for Building S6233, Surgery and X-Ray. 800 Series, Type HSXR-1, Plan 800-1988.

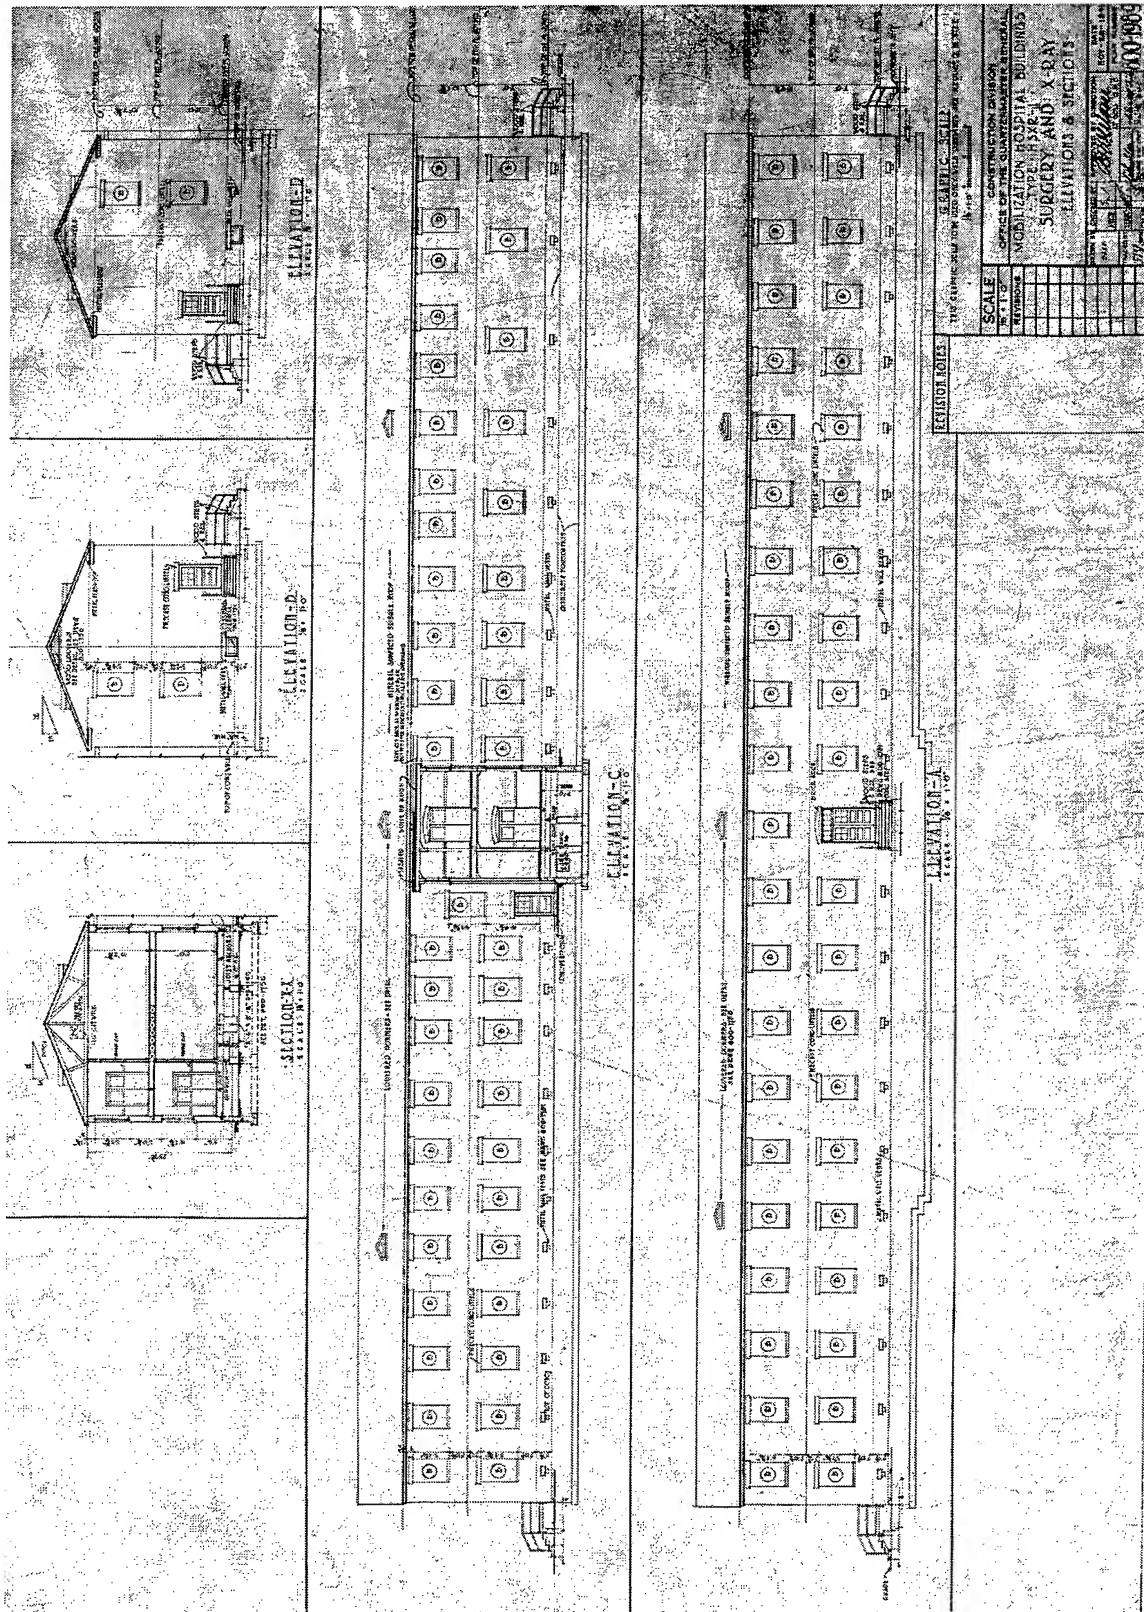
Figure V.56 5EP1778. Elevations and sections for Building S6233, Surgery and X-Ray. 800 Series, Type HSXR-1, Plan 800-1989.

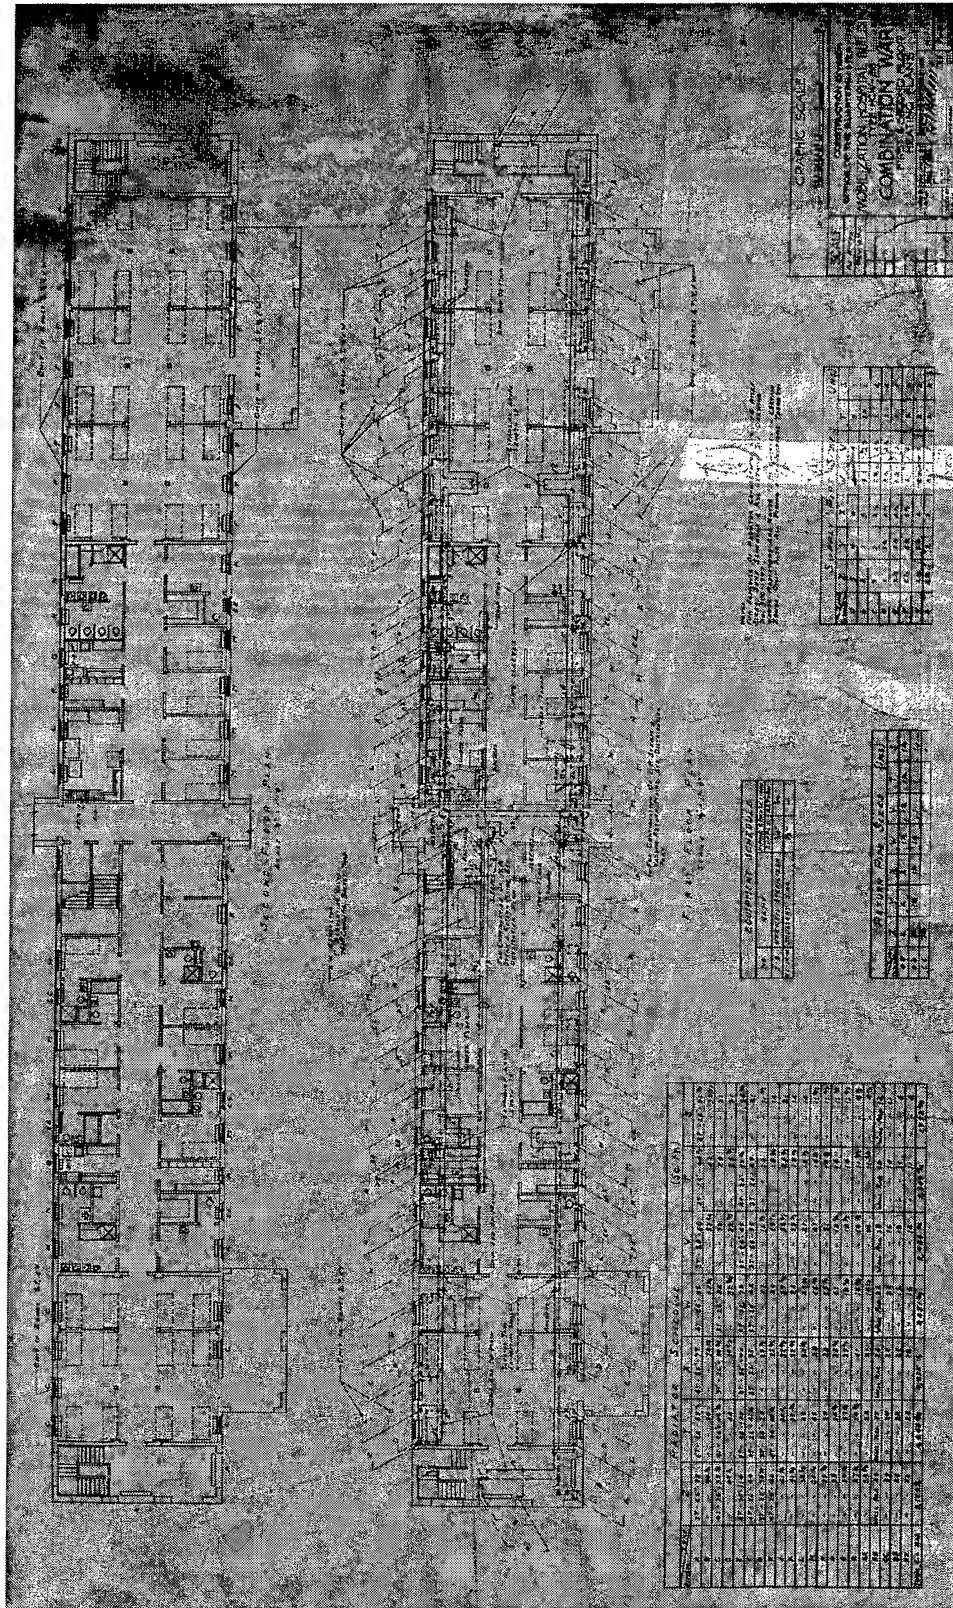
Figure V.62 5EP1778. First- and second-floor heating plans for Building S6230, Combination Ward. 800 Series, Type HCW-88, Plan 800-1946.

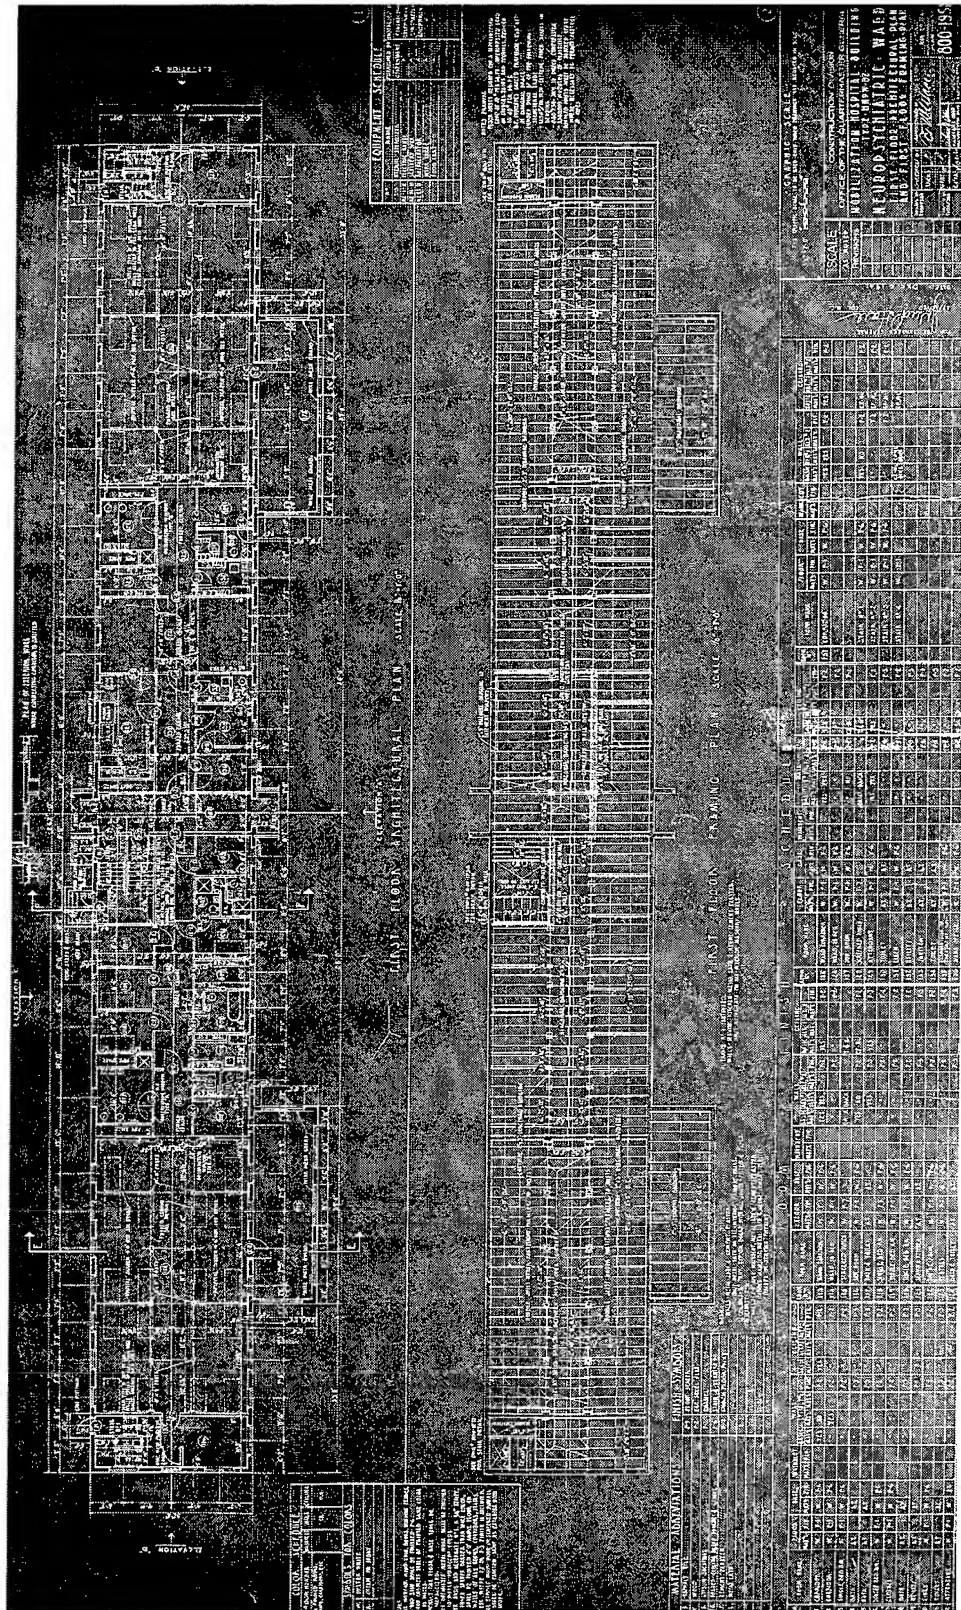
Figure V.73 SEP1778. First-floor architectural and framing plans for Building S6253, Neuropsychiatric Ward, 800 Series, Type HNPW-82, Plan 800-1958.

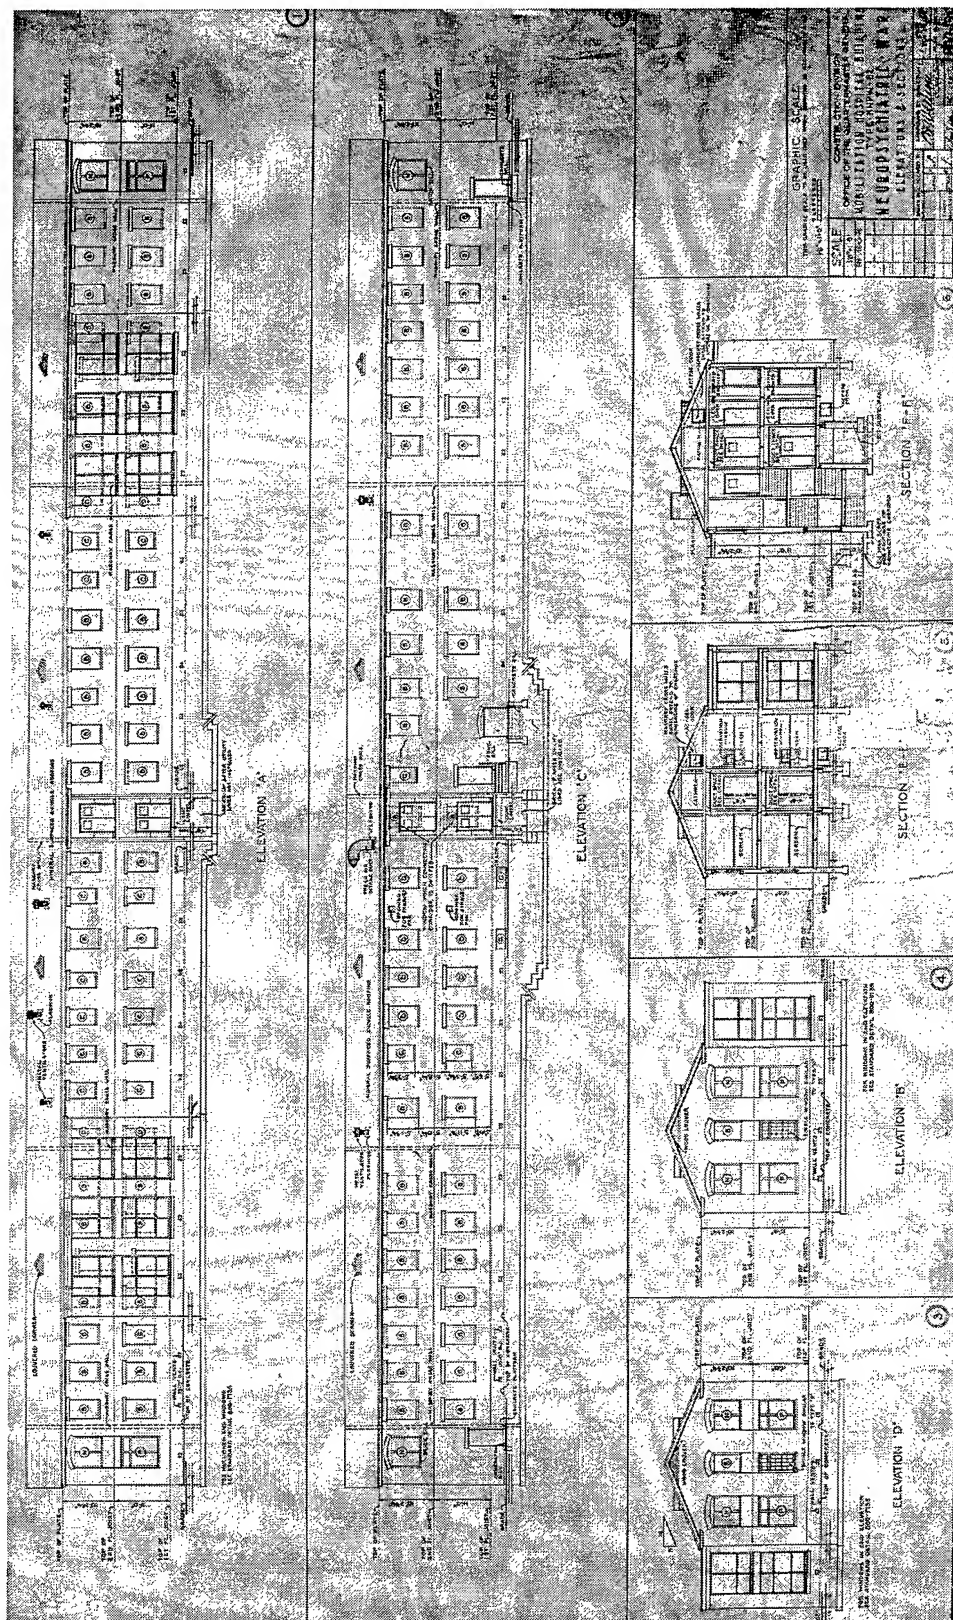
Figure V.75 5EPI778. Elevations and sections for Building S6253, Neuropsychiatric Ward. 800 Series, Type HNPW-82, Plan 800-1960.

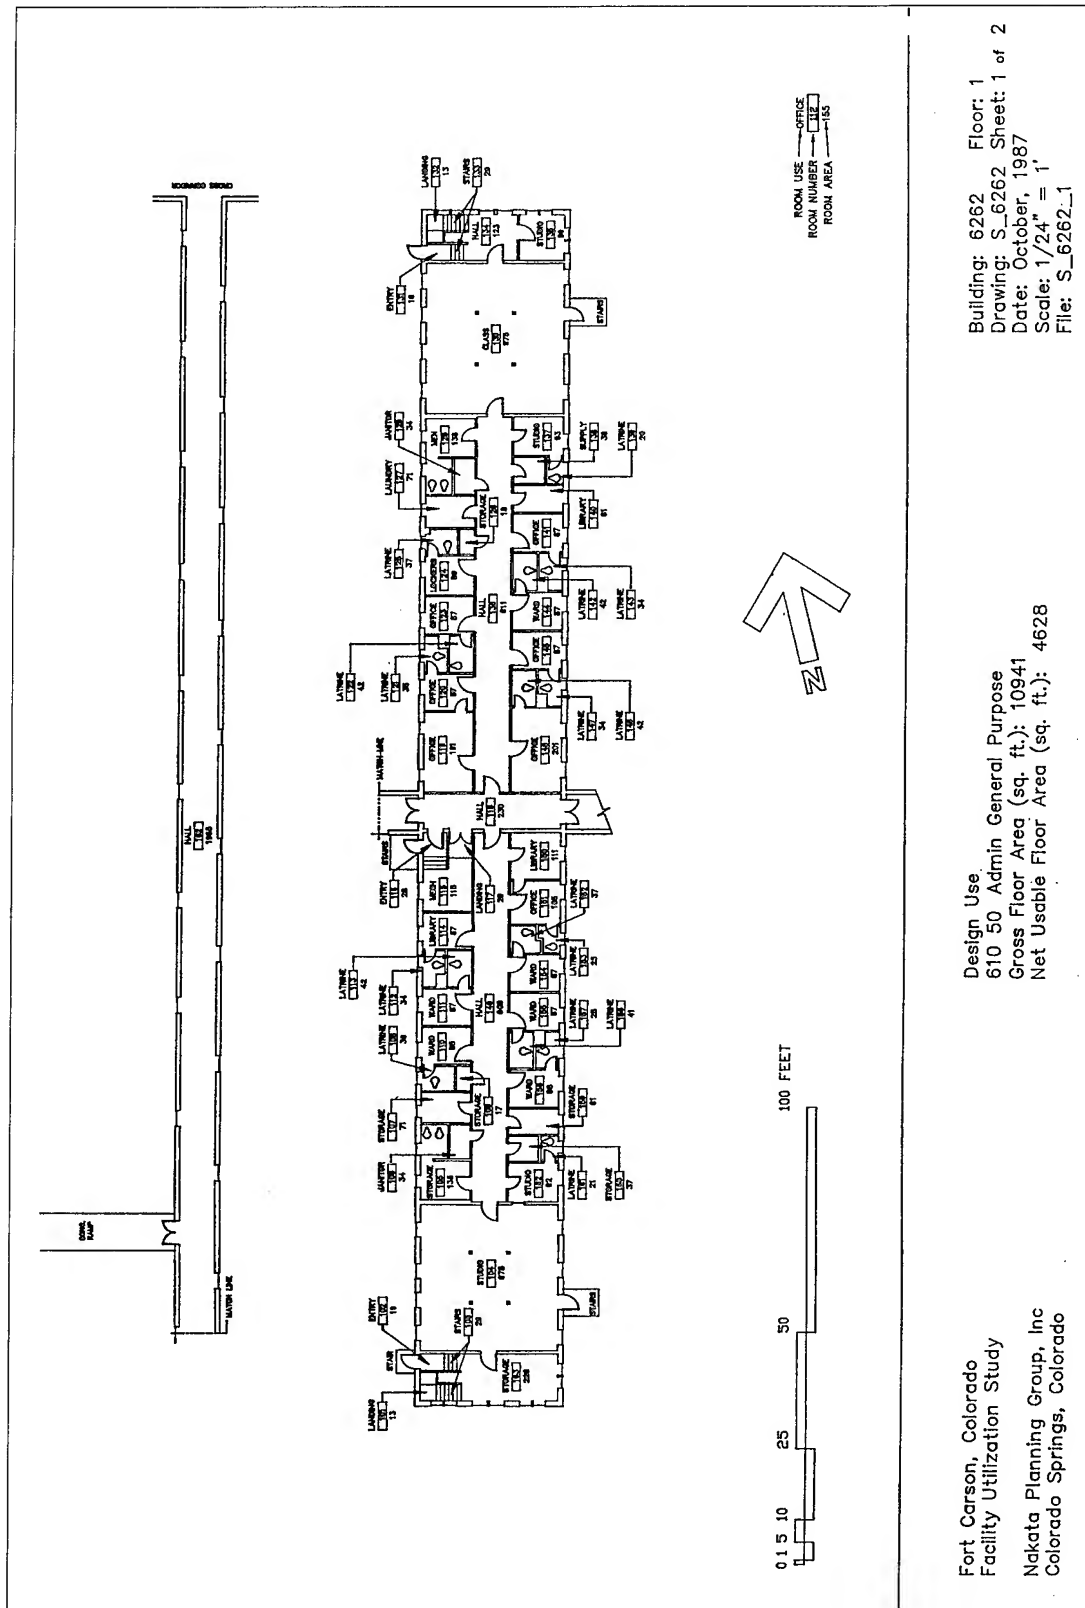
Figure V.89 5EP1778. First-floor plan for Building S6262, Special Ward, BUD Series.

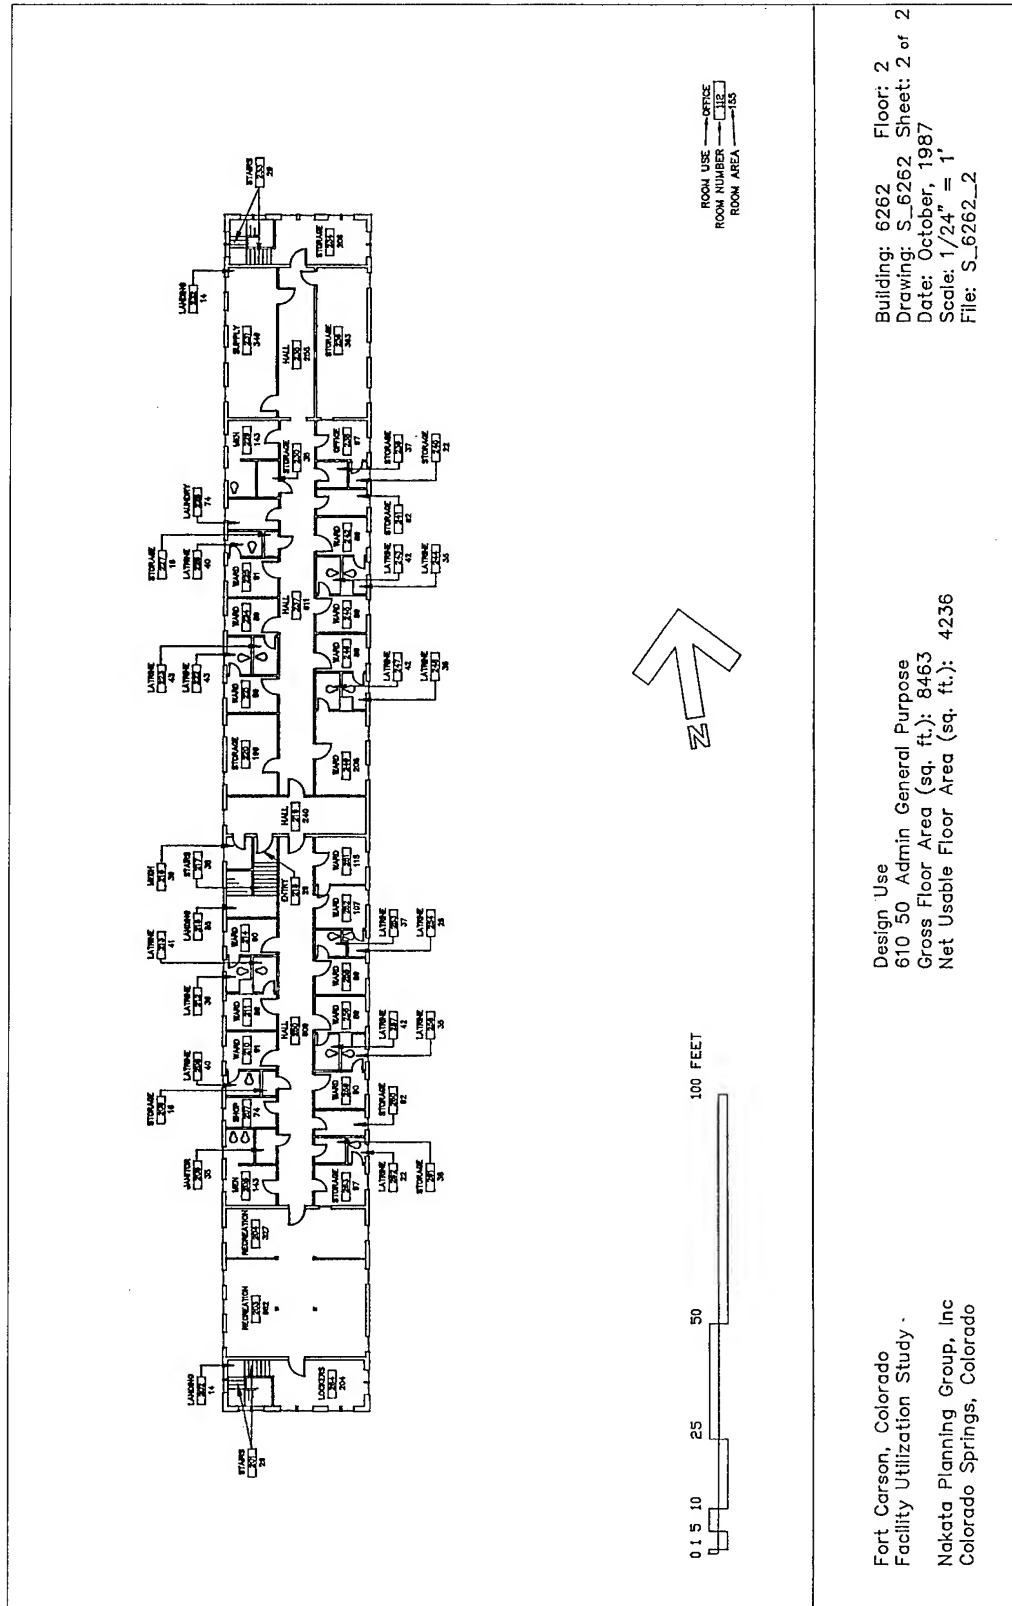
Figure V.90 5EP1778. Second-floor plan for Building S6262, Special Ward, BUD Series.

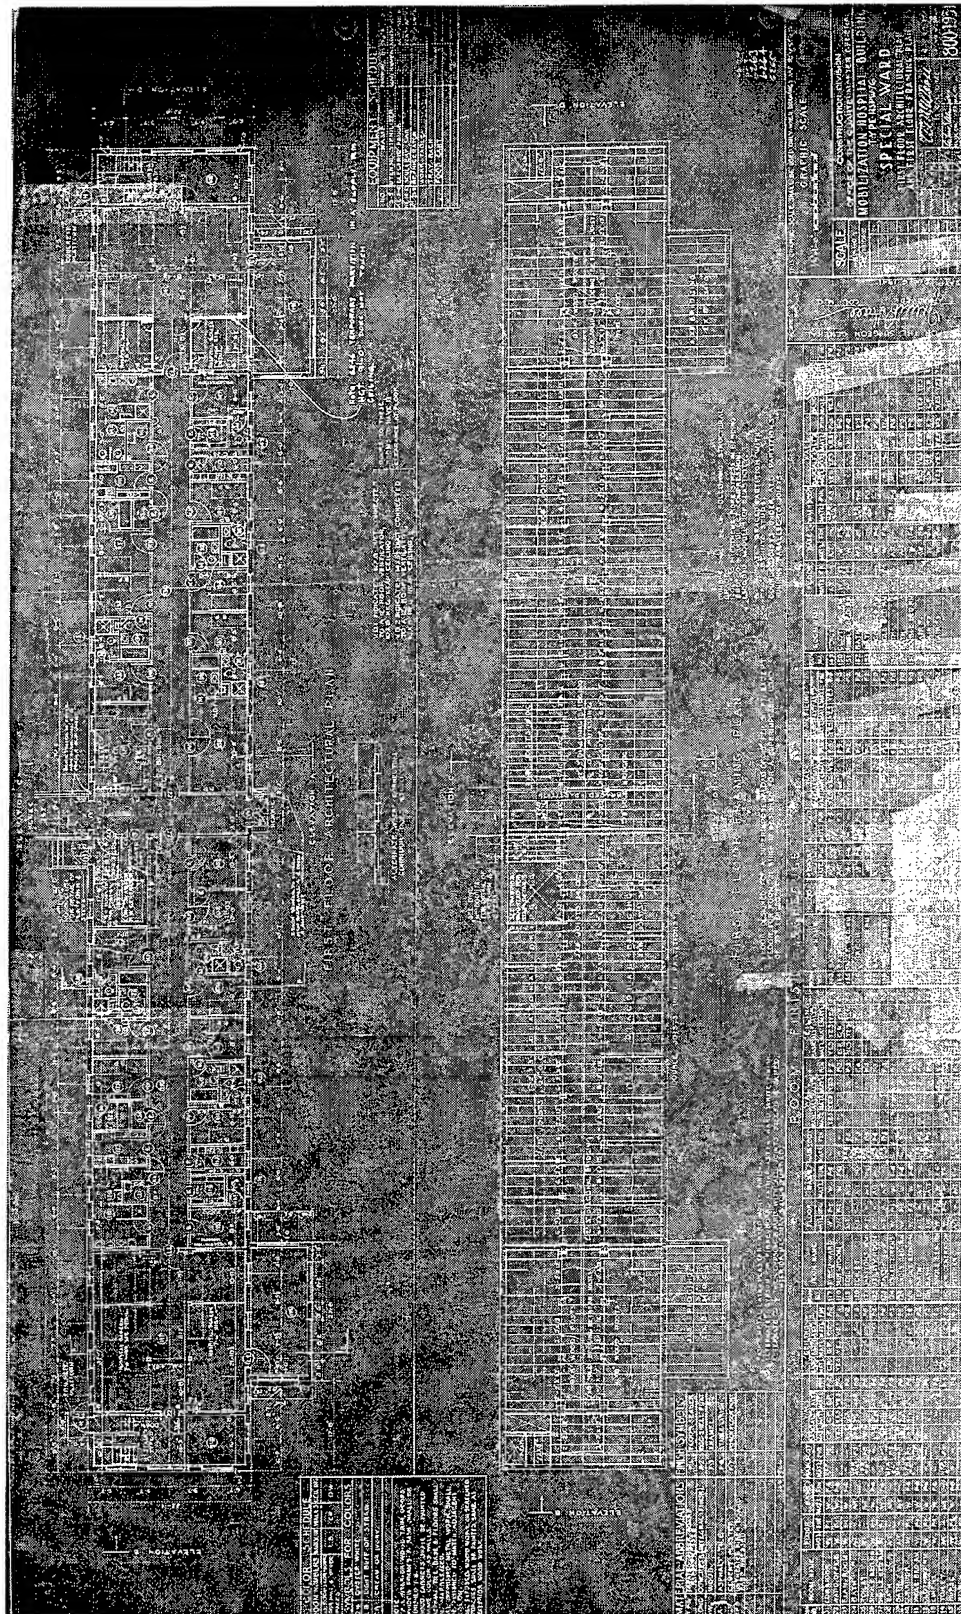
Figure V.91 SEP1778. First-floor architectural and framing plans for Building S6262, Special Ward, Type HSPW-76, Plan 800-1951.

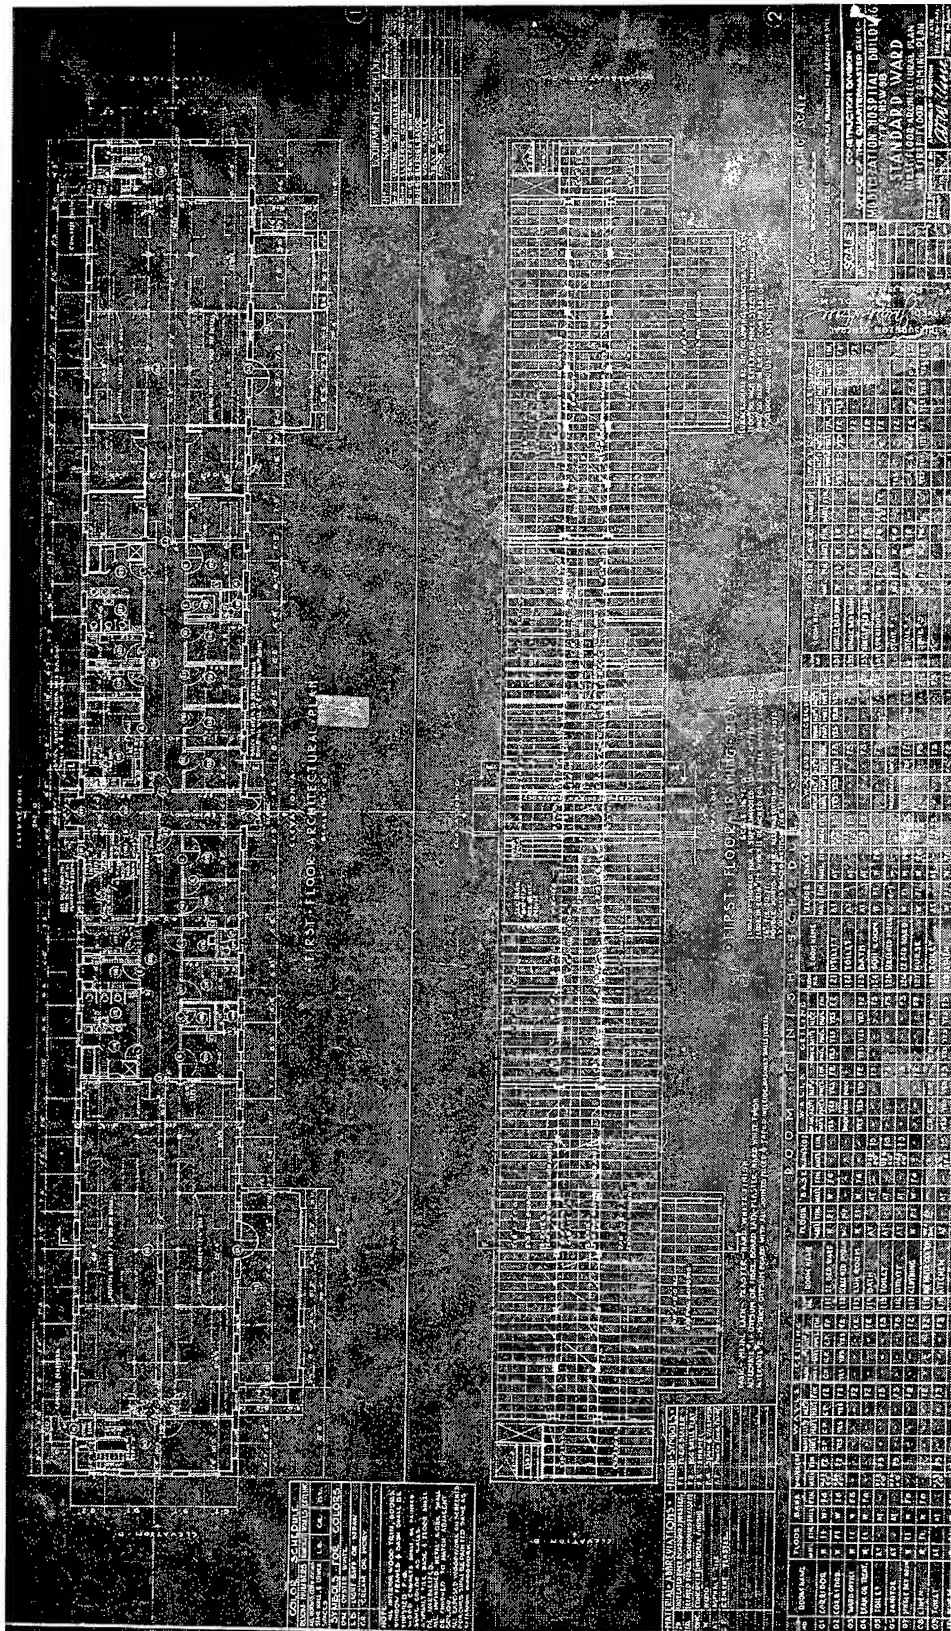
Figure V.106 5EP1778. First-floor architectural and framing plans for Building S6252, Standard Ward, 800 Series, Type HSW-98, Plan 800-1935.

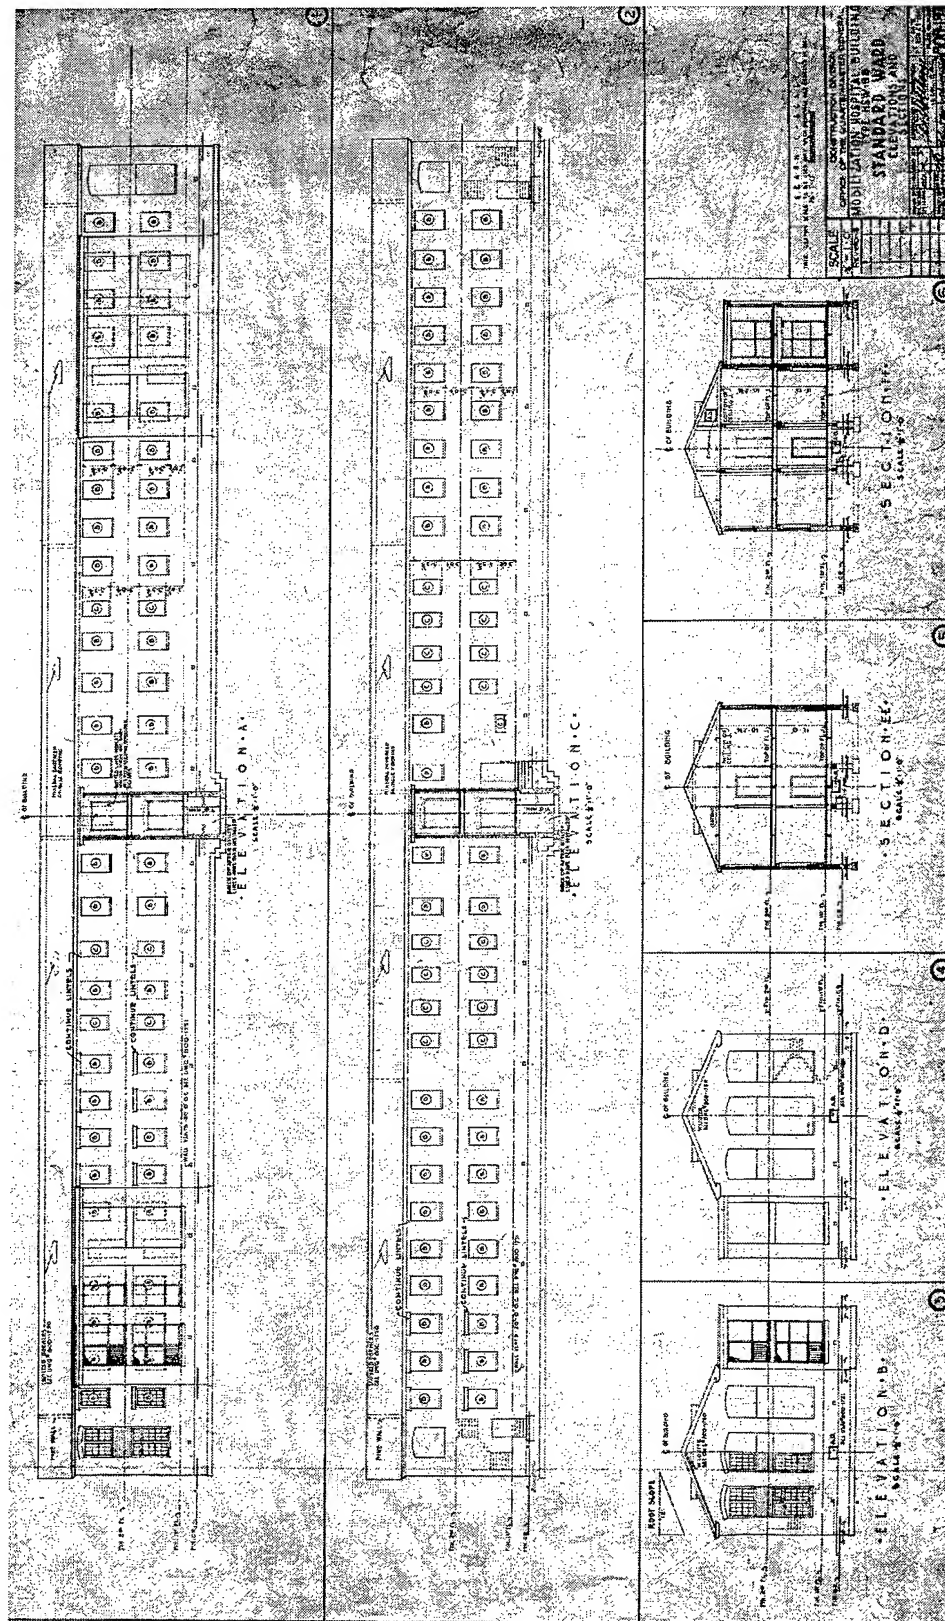
Figure V.108 SEP1778. Elevation and section plans for Building S6252, Standard Ward, 800 Series, Type HSW-98, Plan 800-1937.

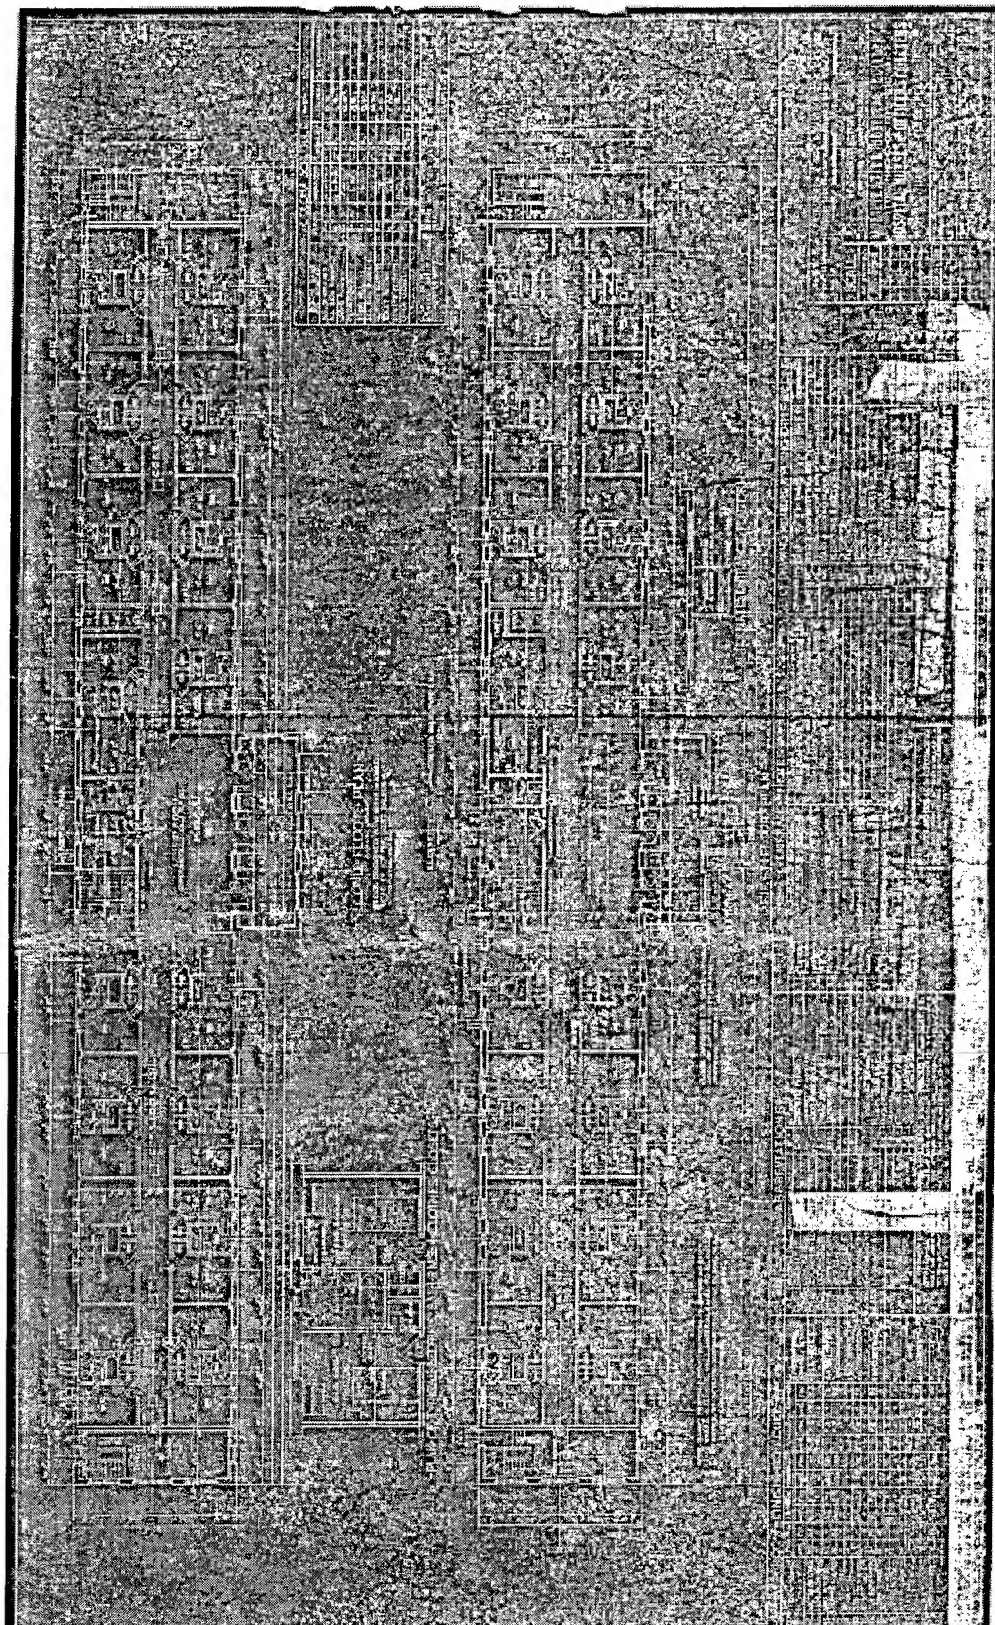
Figure V.119 SEP1778. First- and second-floor plans for Building S6222, Hospital Nurses or Officers Quarters, 800 Series, Type HNQ-63 or HOQ-63, Plan 800-1836.

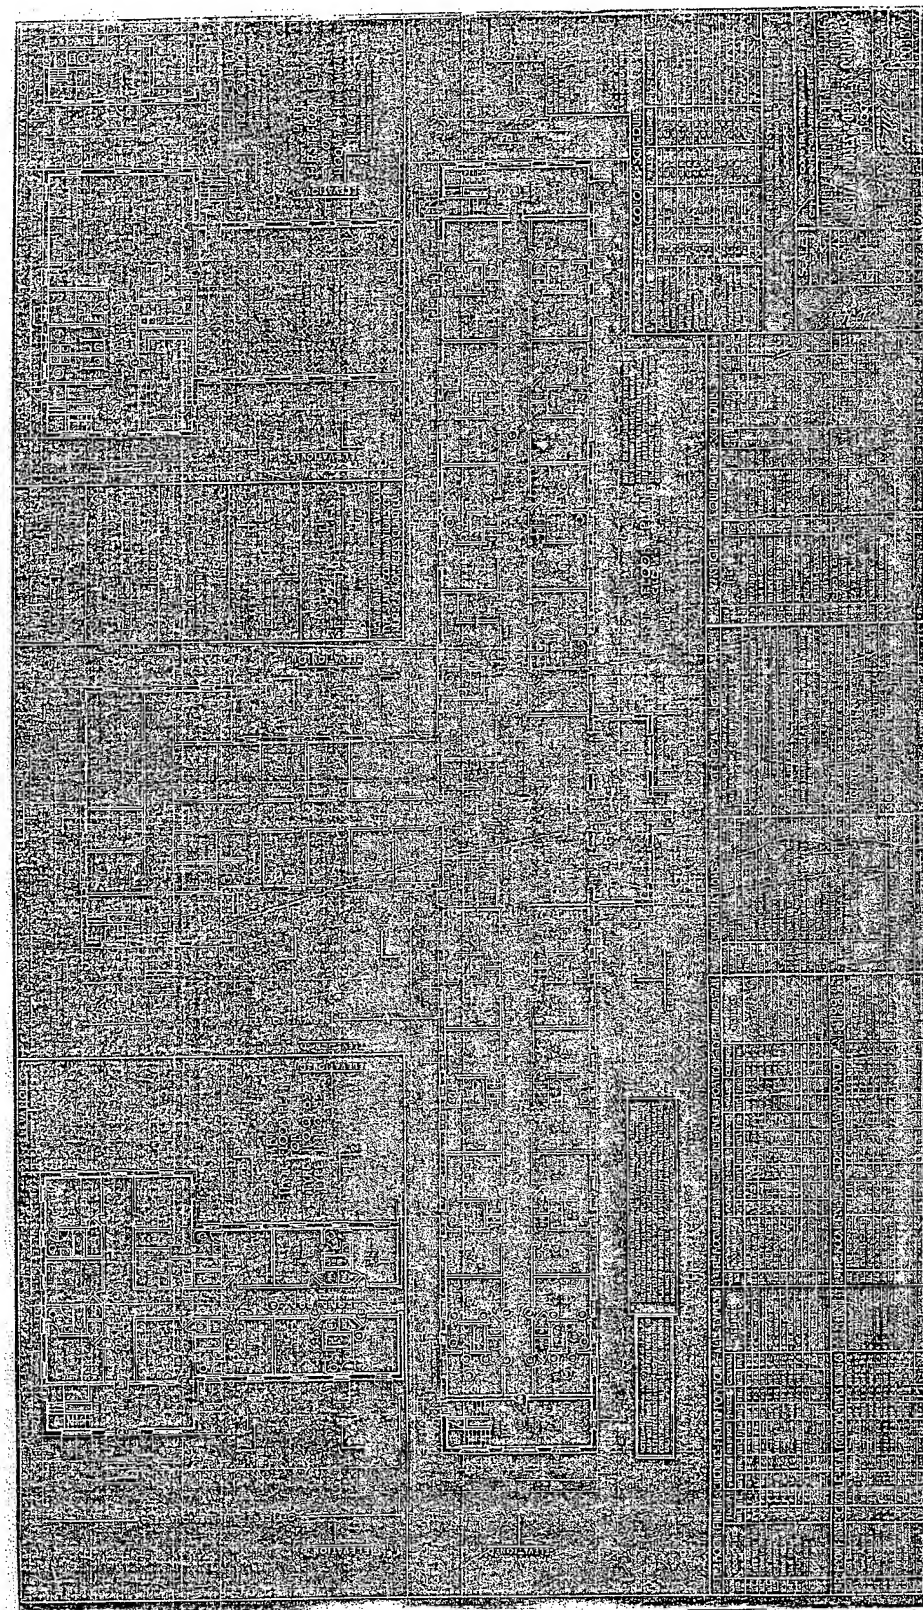
Figure V.132 SEP1778. First-floor plan for Buildings S6224 and S6228, Hospital Nurses or Officers Quarters, 800 Series, Types HOQM-63, HNQM-63, HNQMS-63, HOQM-74, HNQM-74, HNQS-74, HOQ-85, and HNQ-85, and HNQ-1844. Plan 800-1844.

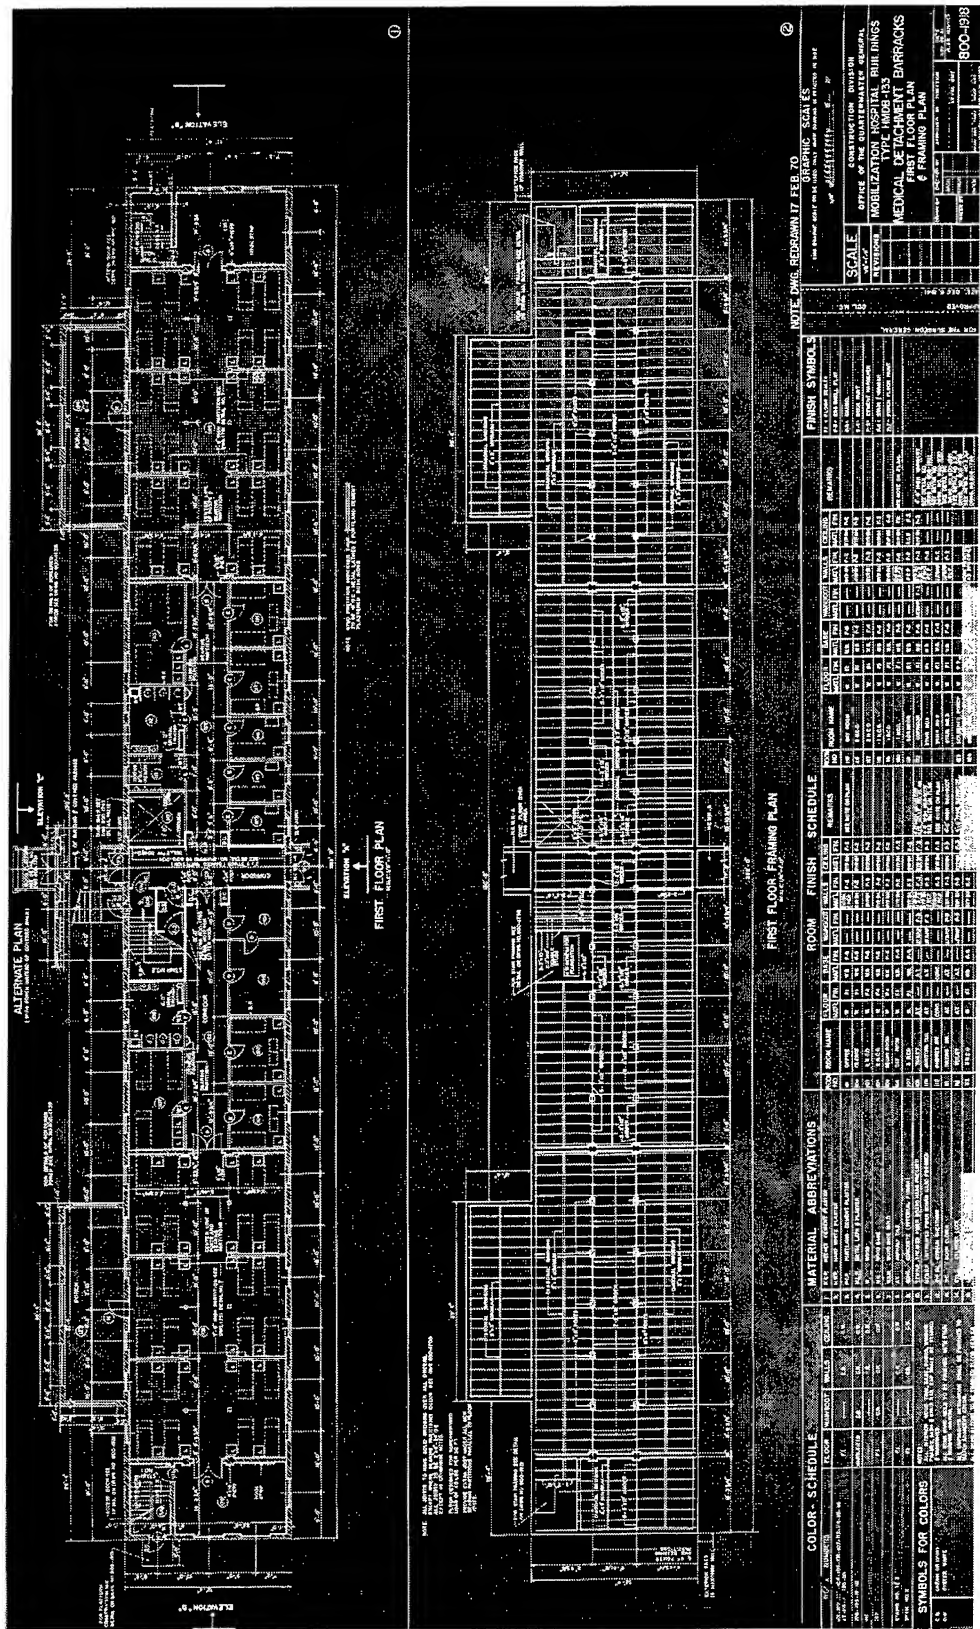
Figure V.141 SEP1778. First-floor plan and framing plan for Building S6281, Medical Detachment Barracks, 800 Series, Type HMDB-133, Plan 800-1918.

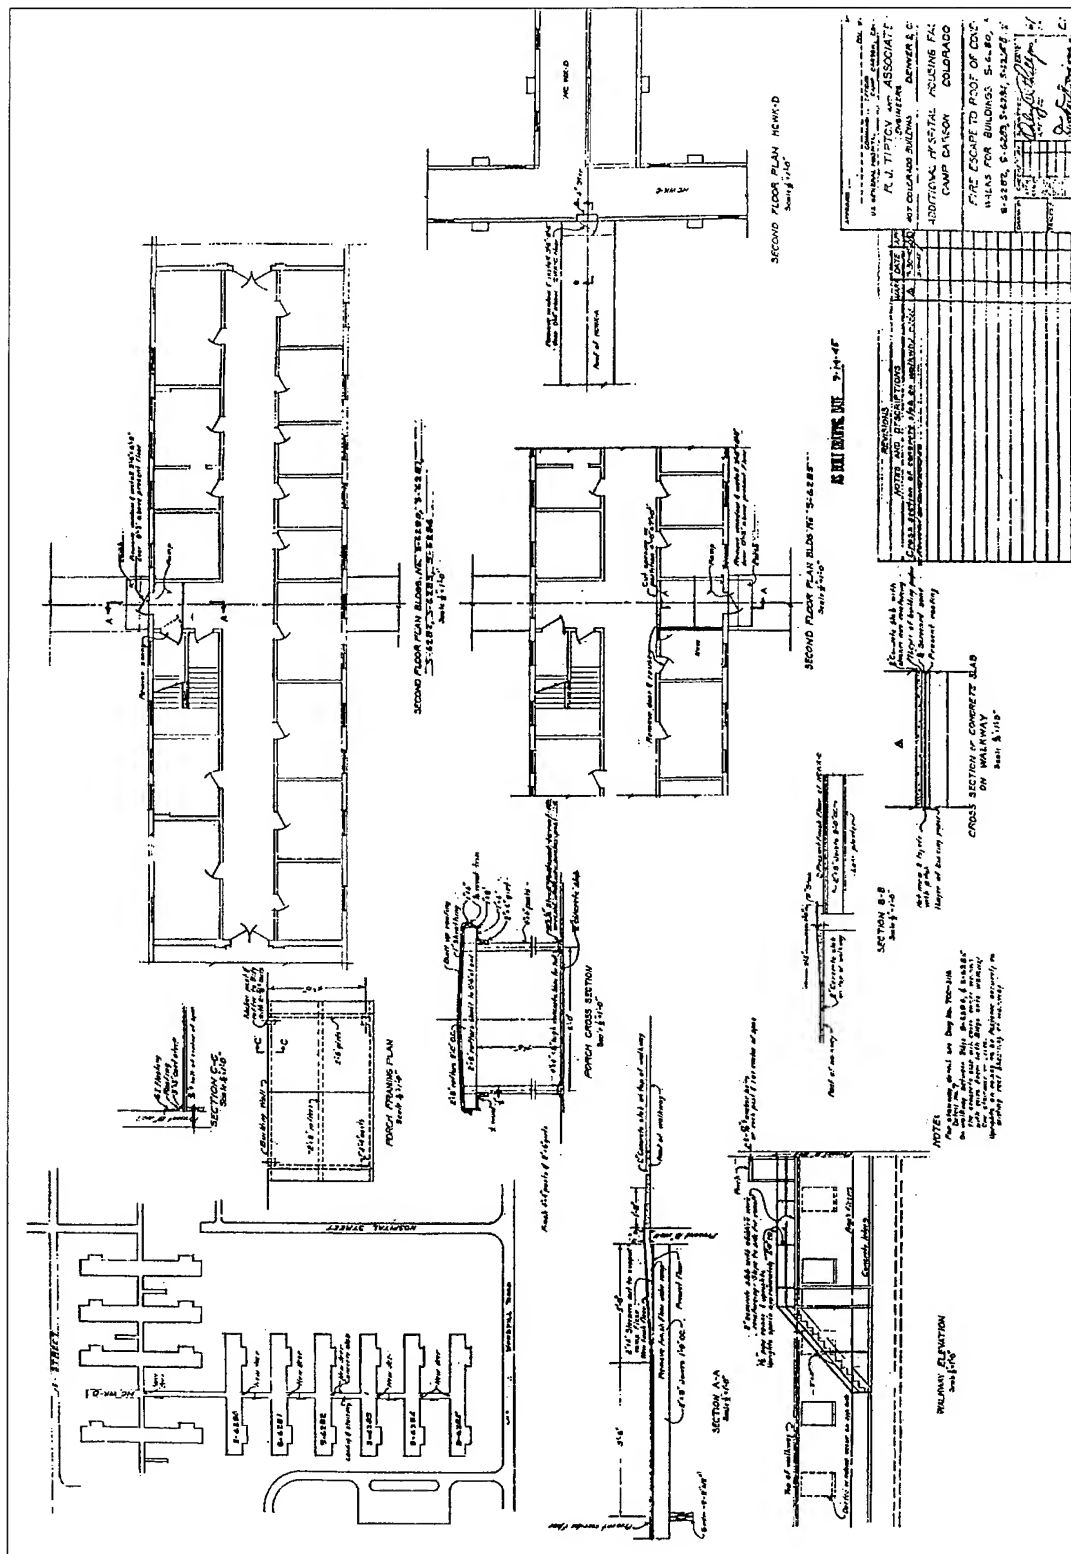
Figure V.144 5EP1778. Fire escape plan for Building S6281, Medical Detachment Barracks, CCH Series, Sheet (illegible).
